NASA Contractor Report 3794

# Repair Techniques for Celion/LARC-160 Graphite/Polyimide Composite Structures

J. S. Jones and S. R. Graves

CONTRACT NAS1-16448  
JUNE 1984

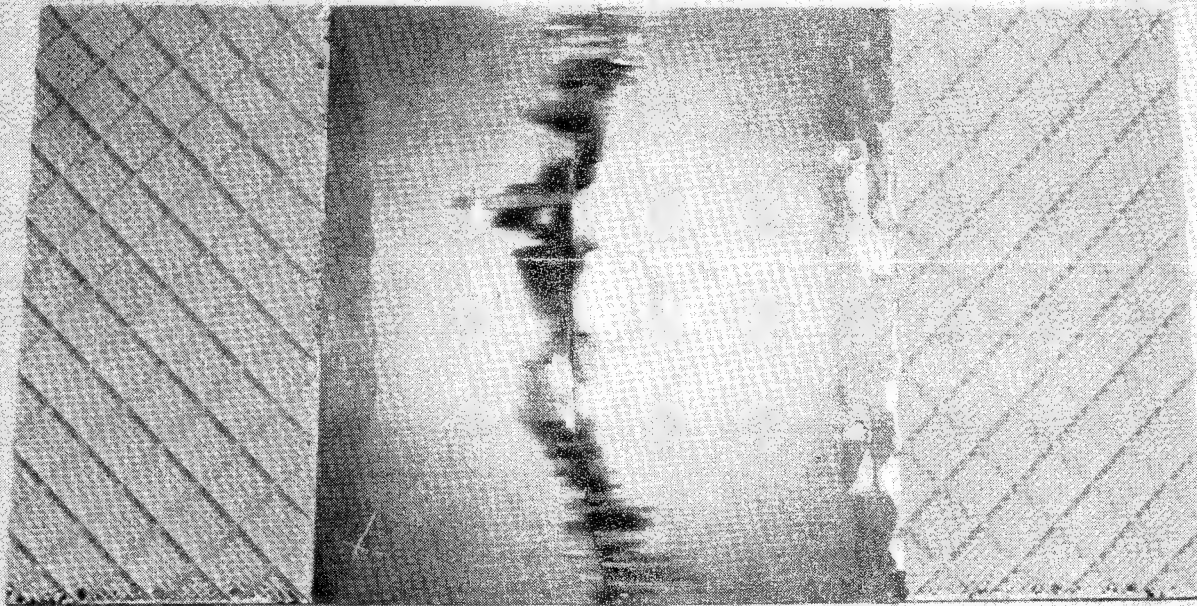
Figure 6-24. 7.62 cm (3.00 in.) Diameter External Cocure Patch on a  
2.54 cm (1.00 in.) Diameter Hole; Specimen EX398-5

Table 6-1 and can be seen typically in the photographs of the failed specimens in Figures 6-21 through 6-25. These photographs show both the patch side and the back side of the test specimens. The 3-degree scarf flush repair resulted in the greatest load transfer, and greatest strength increase over the damaged laminate strength. The load transfer by the external patch repairs is somewhat less than anticipated. Test specimens EX358-2 and EX358-5 are identical except that the latter has an external patch and had a much lower failure level. Only a few external patch specimens were fabricated. It is anticipated that current improvements in repair processes could result in higher failure levels for future external patch repairs.

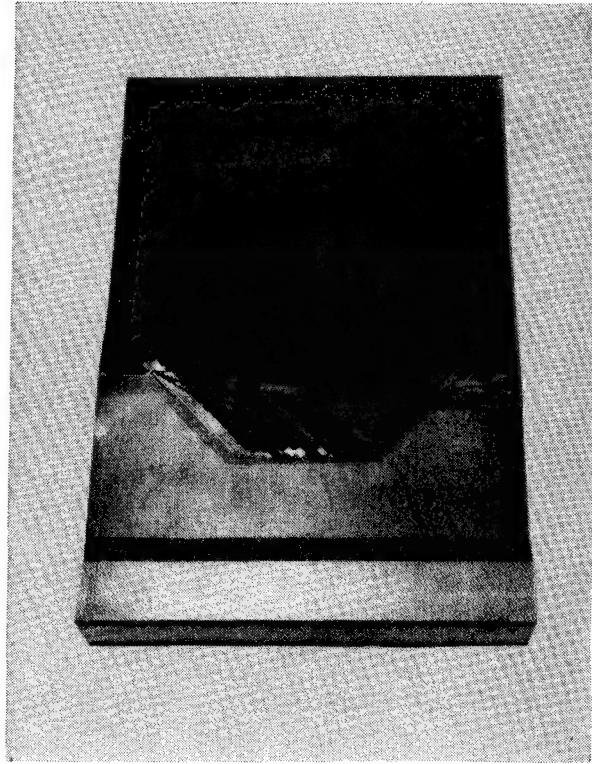
FAILURE MODE: SHEAR FAILURE UNDER PATCH AND SKIN COMPRESSION,  
ULTIMATE LOAD (LB/INCH): 8,282  
71.1% OF CONTROL

Figure 7-19. Heavily Loaded Sandwich Specimen Repair, EX483/483-1  
(0,  $\pm 45$ , 90)<sub>2s</sub> Transverse-Oriented Outer (0) Fibers--  
Failure Mode; 316°C (600°F) Test

Three repaired transverse oriented 0-degree outer fiber specimens were compression tested and joint efficiencies range between 75.7 and 90.6 percent of transverse-oriented fiber undamaged control specimens. Two specimens failed by combined shear-out of the repair patch and compression failure of the repair patch and parent laminate skin. The third and highest load bearing specimen failed by parent laminate skin compression outside the repair area. Photographs showing specimens and modes of failure are presented in Figures 7-17, 7-18, and 7-19.
